PRODUCT SUPPORT TECHNICAL BULLETIN

August 31, 2023

Issue: Ice Temp Sensor is a redundant sensor that should be disabled.

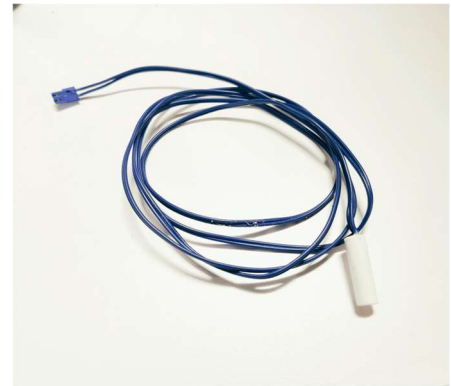
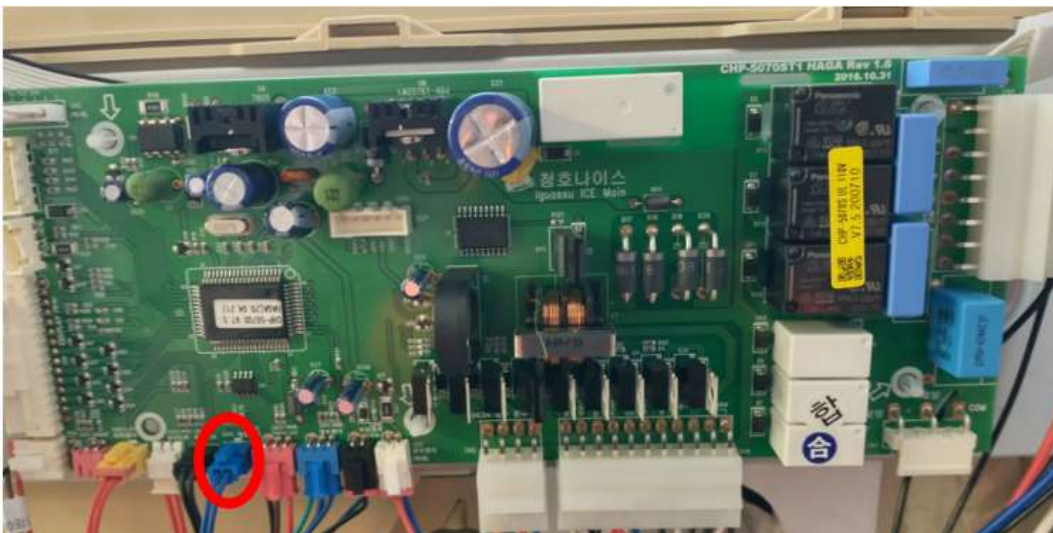
1. Unplug the unit from the outlet.
2. Gain access to the PCB.
3. Unplug the Ice Temp Sensor, circled below.
4. Plug the unit back into power and confirm proper operation.

Disconnect Ice Temp Sensor from PCB.
