## HOT TANK OVERHEAT (ROR PROTOCOL TRIGGERED)

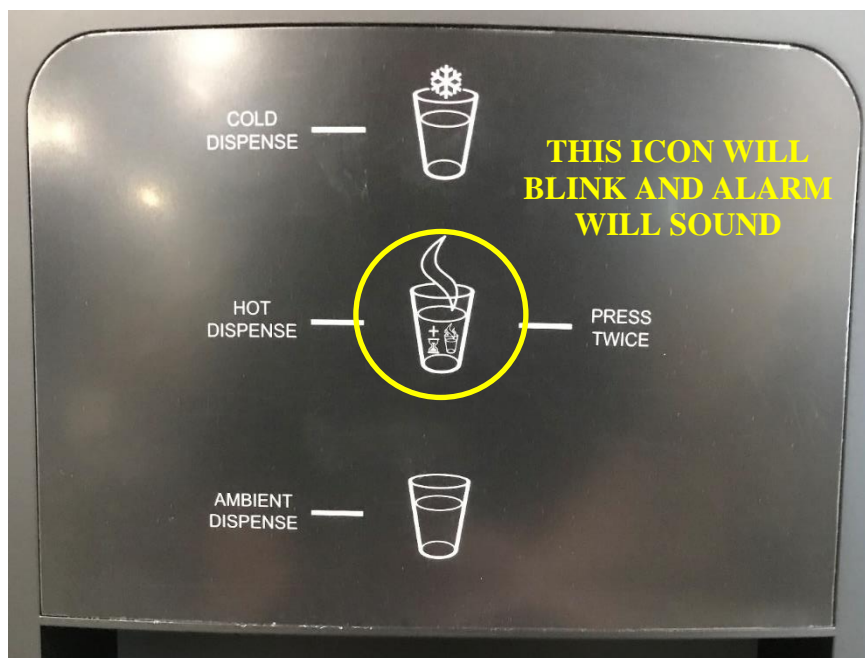
The **WL3 FX Water Treatment System** has an ROR (Rate of Rise) protocol in the programming that will disable the hot tank and give audible and visual alarms if the temperature in the Hot Tank rises too rapidly, which usually indicates dry heating. The Hot Tank **MUST HAVE WATER IN IT** before the Green heater/compressor switch is turned on. Heating without water can damage the tank and the machine.

If this occurs, disconnect the machine from power for 10 seconds to allow the alarm to reset. Turn OFF the Green switch. Reconnect to power, with the Red Power switch ON and the Green switch OFF. Dispense water from the hot tank as normal. Once water flows, turn the Green switch back ON. If there is no water flowing from the hot tank, investigate further for other potential failures.
