HOT TANK OVERHEAT (ROR PROTOCOL TRIGGERED)

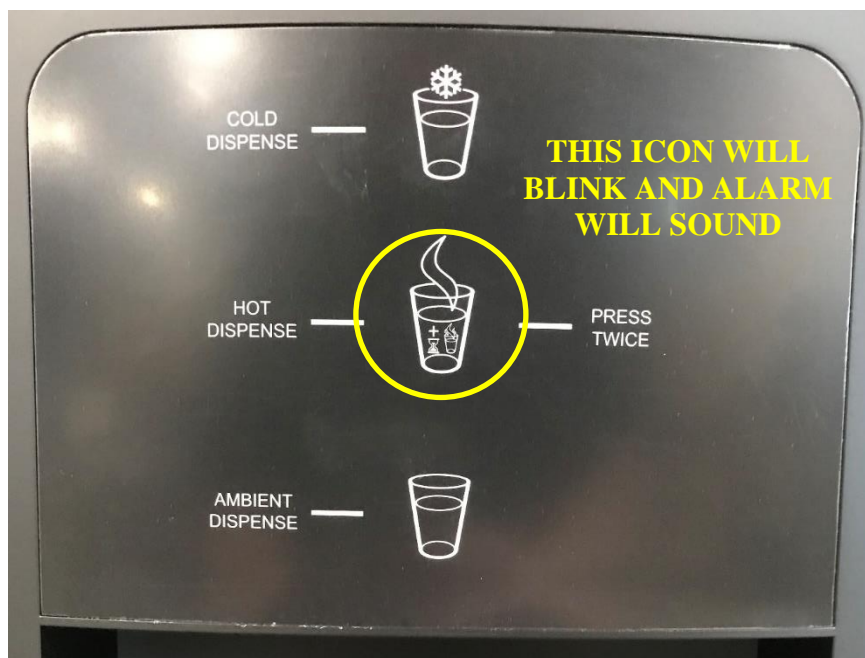
The **WL3 FX Water Treatment System** has an ROR (Rate of Rise) protocol in the programming that will disable the hot tank and give audible and visual alarms if the temperature in the Hot Tank rises too rapidly, which usually indicates dry heating. The Hot Tank **MUST HAVE WATER IN IT** before the Green heater/compressor switch is turned on. Heating without water can damage the tank and the machine.

If this occurs, disconnect the machine from power for 10 seconds to allow the alarm to reset. Turn OFF the Green switch. Reconnect to power, with the Red Power switch ON and the Green switch OFF. Dispense water from the hot tank as normal. Once water flows, turn the Green switch back ON. If there is no water flowing from the hot tank, investigate further for other potential failures.
