PRODUCT SUPPORT TECHNICAL BULLETIN

Issue: S4 Leak from Elbow Connected to the Cooling Coil

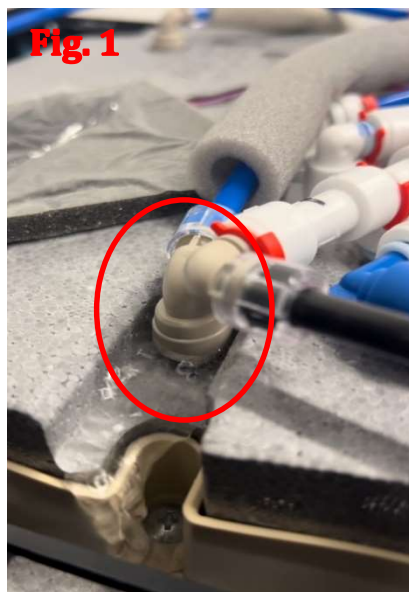
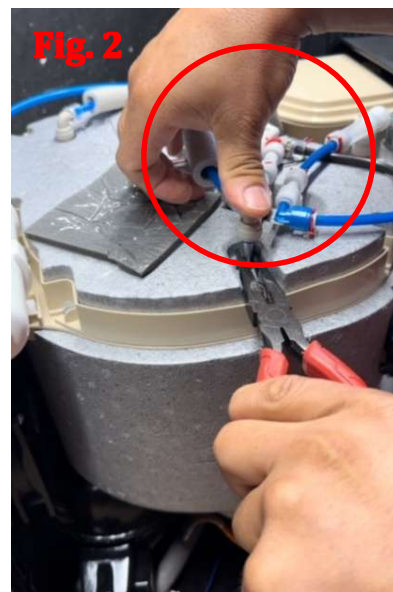
The elbow fitting that connects to the cooling coil is not fully seated onto the coil stem coming up from the cold-water bath. This is causing a leak to present itself upon dispensing cold water, **Fig.1.**

Push elbow fitting down until it is fully seated on the cooling coil stem using needle nose pliers to hold the stem in place.

1. Unplug the unit from the outlet and ensure that water to the unit is turned off.
2. Remove the top and left side panels of the unit.
3. Make sure that the leak stop is not engaged, if it is, clear the leak and dry the floor pan.
4. Locate the elbow on the left side of the cold-water bath lid.
5. Pull the fitting up to expose the cooling coil stem.
6. Using needle nose pliers, gently hold the stem in place while pushing down on the elbow to seat it all the way down on the stem, **Fig.2.**
7. Plug unit back into the outlet, turn the water supply on and dispense cold water to ensure the leak is resolved.
8. Reassemble unit.
