PRODUCT SUPPORT TECHNICAL BULLETIN

Topic: WL900 SS Auger Motor Coupler

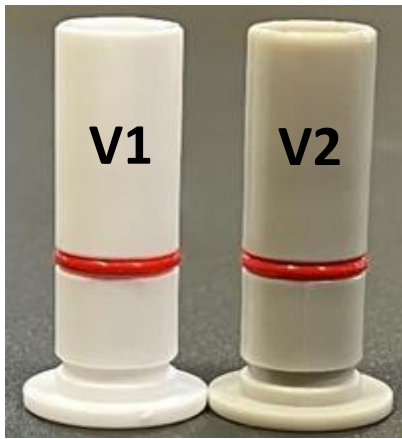
22-1290 (obsolete)

Past versions of the Auger Motor Coupler (22-1290) were made of high strength resins but were problematic. The newest version of the Auger Motor Coupler (22-1290SS) has been made of Stainless Steel and has also combined the Coupler with the Coupler Connector. Less parts to fail or lose. The new Coupler displays superior strength, consolidates parts, and does not have any negative effects on the operation of the unit. Shown below are past versions of the Coupler and the now-obsolete Coupler Connector, as well as photos of the new Coupler.

It is our recommendation that any WL900 in the field have the 22-1290 and 22-1265 uninstalled and the 22-1290SS installed in their place.
