## FAULT CODE TROUBLESHOOTING INDEX

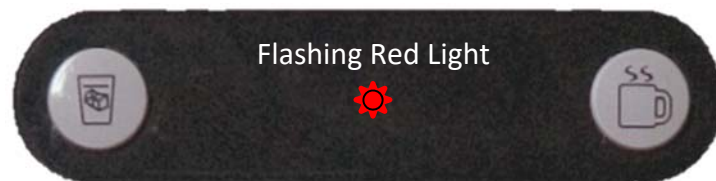
### **1. FAULT CODE: Red Flashing LED Light and Audible Alarms are the Leak Detector Alarms for Counter Top Model**

Possible Reason	Solution
Water exiting drip tray due to being full	Empty Drip Tray. Remove Top cover and Front Panel prior to drying out inside of the unit.
Leak in <b>WL250</b> Counter Top	Water is in the bottom of the unit. Open up unit to determine where the leak is.  Check for source of leak. Dry out inside of unit.

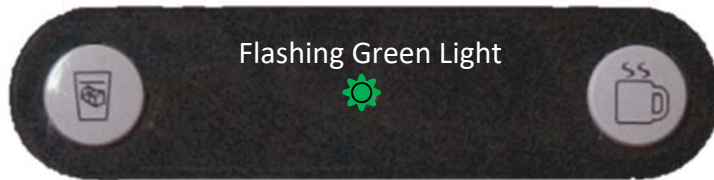
**2. FAULT CODE: Green Flashing LED light indicates the PCB CDS DIP switch turned to OFF**

Possible Reason	Solution
CDS Sensor switched to OFF	Change CDS DIP Switch's on the PCB for Leak Detection Part Number 12-3115 (Factory PN EN-6085A) to ON.

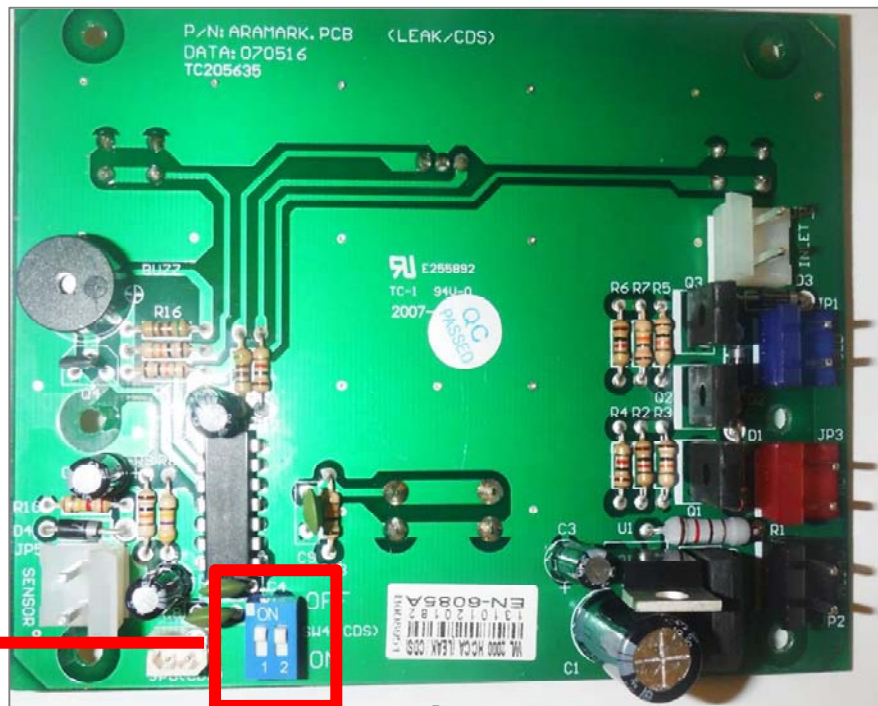
Both switches to be in ON position as shown
